# **VEHICLE INSPECTION REPORT**

PF70UOU

## Fiat Ducato 35 MAXI 2.3 MULTIJET 140PS

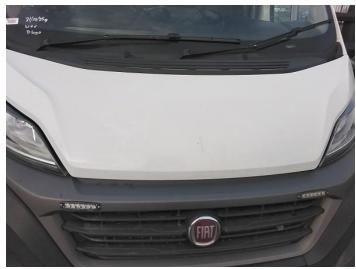
1: Bonnet Chipped Multiple Chips

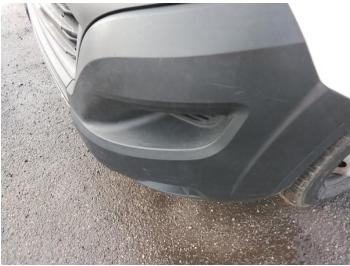
2: Bumper Front Moulding Scuffed (Unpainted) Over 100mm

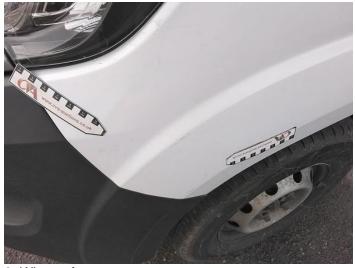
3: Wing nsf Scratched Over 25mm Thru Paint

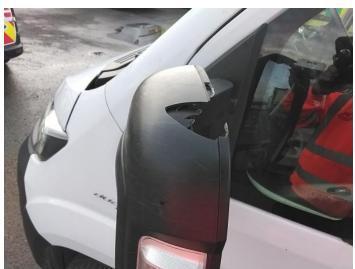
4: Door Mirror Assy nsf Broken Replace

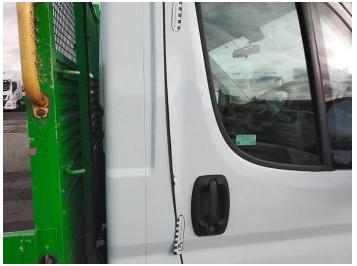
5: Door osf Dented With Paint Damage

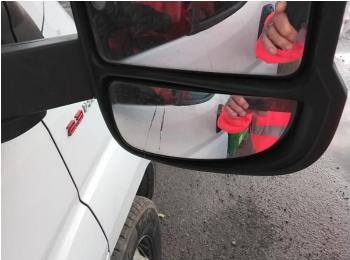
6: Door Mirror Glass os Broken Replace

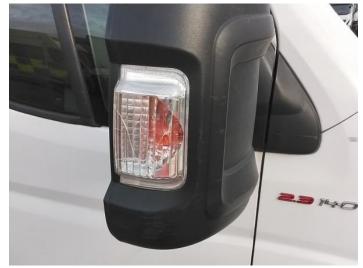
7: Door Mirror Assy osf Broken Replace

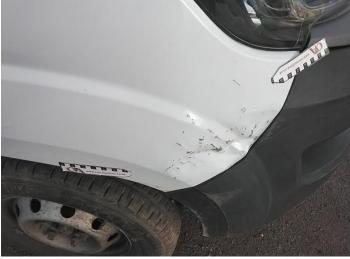
8: Wing osf Dented With Paint Damage

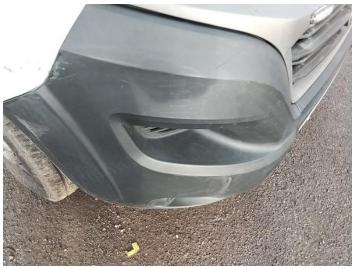
9: Bumper Front Moulding Scuffed (Unpainted) Over 100mm

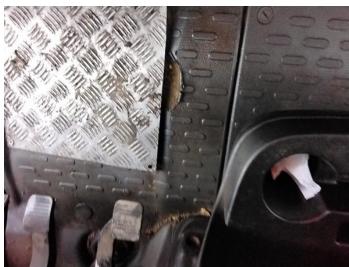
10: Carpets Front Holed Over 3mm

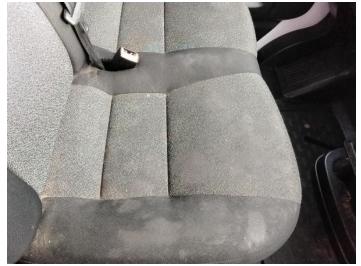
11: Seat Base Cover nsf Soiled Heavy
